VPE Software – Agilent Cary Win UV “Macro Already Running”

Abstract: This document has been prepared to detail the cause, implications and risks associated with the Agilent Cary Win UV “Macro Already Running” error message that can sometimes be observed in the SoloVPE Software in response to a User double-click action on an ADL created screen control.

Applicability: This article applies to all software application built for the Agilent Cary Win UV environment that leverage the ADL scripting language that is included as a standard feature within the Agilent Cary Win UV Environment. It applies to all versions of the Varian and Agilent Cary Win UV environment that runs in the Windows Operation System (Version 2.x through 5.x) and all versions of the SoloVPE Software.

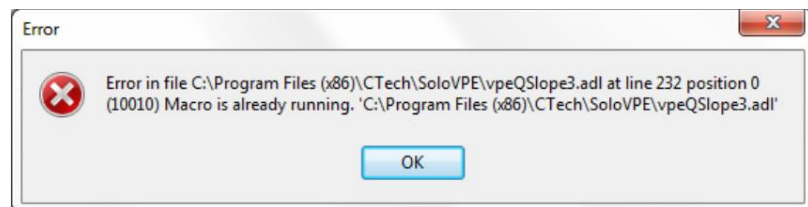
Detailed Info: There is an observed behavior that occurs in the SoloVPE Software when a user intentionally or inadvertently double-clicks a sidebar screen controls within the Cary Win UV environment that has been created through the ADL scripting language that is included with the Cary Win UV software. When this action occurs an “Error” message box is displayed alerting the user that an exception event has taken place. The error message that is displayed is a “raw” message box or unhandled exception as opposed to a handled or trapped event in which the software developers anticipate the possibility of occurrence, intercept the error event and program the code to gracefully and safely deal with and guide the users out of the exception event.

The nature of the message can be discerned from a number of behaviors and characteristics that clearly indicate this is a Cary Win UV message and not a handled event.

- The style of the message box and the included details such as file names, line numbers and position information show that this is a low-level message.
- The lack of user options to do anything other than acknowledge the event.
- The appearance of the ADL Code window menu bar within the Cary Win UV environment

The software response can contribute to user confusion and alarm. Unfortunately, the behavior is one that cannot be mitigated through the tools available in the Cary Win UV environment. As noted, the root cause of the behavior is double-clicking of a sidebar screen control by the user. The behavior is directly associated with the ADL and Cary Win UV architecture. The ADL feature is an enabling piece of technology because it allows for the customization of the Cary Win UV environment which in this case allowed C Technologies to create a powerful new tool in variable pathlength spectroscopy. It allows knowledge developers to create buttons and other screen objects to let users control hardware, software, and new features and functions. It does so through a series of code files that are accessible through the user interface. When a sidebar button is created in the environment there is a code file containing a macro that is associated with that button. When the button is pressed the macro runs. A user unfamiliar with the interface or with high sensitivity to mouse button click actions can mistakenly double-click a button when only a single click is necessary. At times users may not even be aware that the computer interpreted a double-click and they are confronted by an unexpected message and behavior in the software.

There are a number of factors and actions that implementation teams can take to mitigate the impact of this software behavior, many of which can be communicated by C Technologies' support personnel during the familiarization and training activities and as they assist companies in their method development and validation activities. These actions include:

- **User Training:** Help-Desk activities strongly indicate that the double-click event occurs most frequently when users have not received training on the SoloVPE. The implementation of a robust onboarding process for new users of the technology will help prevent the issue from manifesting and make sure only trained and qualified personnel are using the system.

- **Detailed SOP Documentation:** Many organizations include specific details on how to interact with the software including explicit language to emphasize that a single-click or push-button action is required when working in the software. In some instances, the documentation includes a troubleshooting section that explains possible behaviors and the reaction plans which includes the double-click “macro already running” event. The most common response to the event is to close and reopen the SoloVPE software.

- The code files that make up the SoloVPE software customization within the Cary Win UV environment are all contained in a single folder on the computer which should be set as a read-only location with read-only files. By properly configuring the NTFS permissions on that location, it is not possible to modify the code files either inadvertently or through malicious intent. Depending on the operating system in use the code files are found in either the “C:\Program Files\CTech” folder or the “C:\Program Files (x86)\CTech” folder and the subfolders within.
