ProConnex® Steam2® Valve Validation Report

Validation Report

Objective

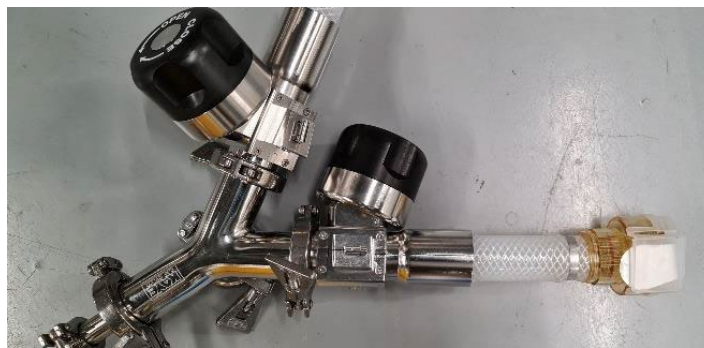
Figure 1. Closed valve assembly for the pressure leak test

Both pressured steam and air pressure were used to demonstrate seal integrity of the large valves. The 1" ID valves and liners were subjected to three pressurized steam cycles at a nominal temperature of 131°C ± 2°C for 75 minutes. The valves were then exposed to 6 bar (87 psi) air pressure for 15 minutes. Valves were tested in both the valve closed ([Figure 1](#)) and valve open ([Figure 2](#)) configurations. Results ([Table 2](#)) show that all test units passed the leak test.

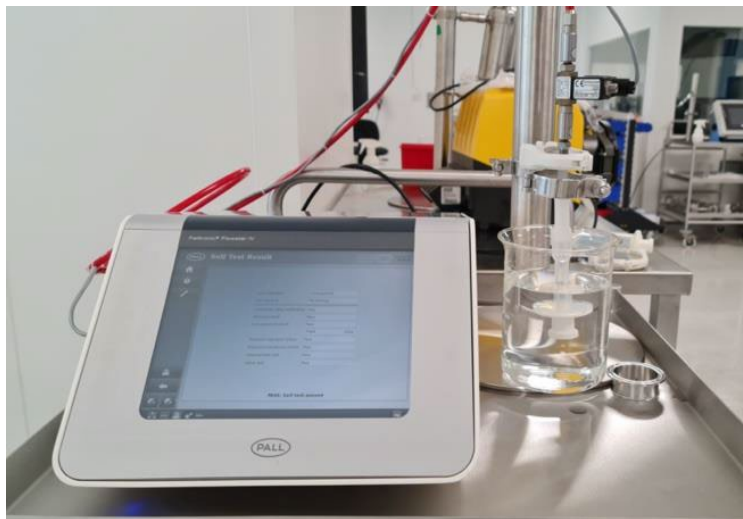
Figure 3. Valve assembly for Functional Testing

The goal of the test was to determine the pressure at which the TC barb plug stops sealing the unsupported liner. The test was performed on valves of both sizes. Each liner was connected to a pressure system ([Figure 3](#)) and pressurized at a 50 mbar (0.73 psi) until leakage. The opposite end of the liner was submerged underwater to observe a leak ([Figure 4](#)). For both valve sizes, the test was terminated after the plug was ejected from the liner. No air leak was observed before the plug ejection. The pressure at which the plug was released was recorded by the automated leak tester ([Table 1](#), [Table 2](#)).

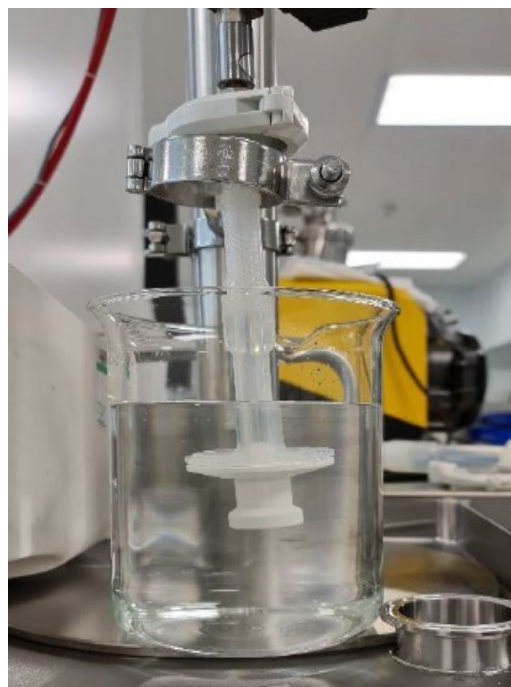
Figure 4. Plug submerged in water

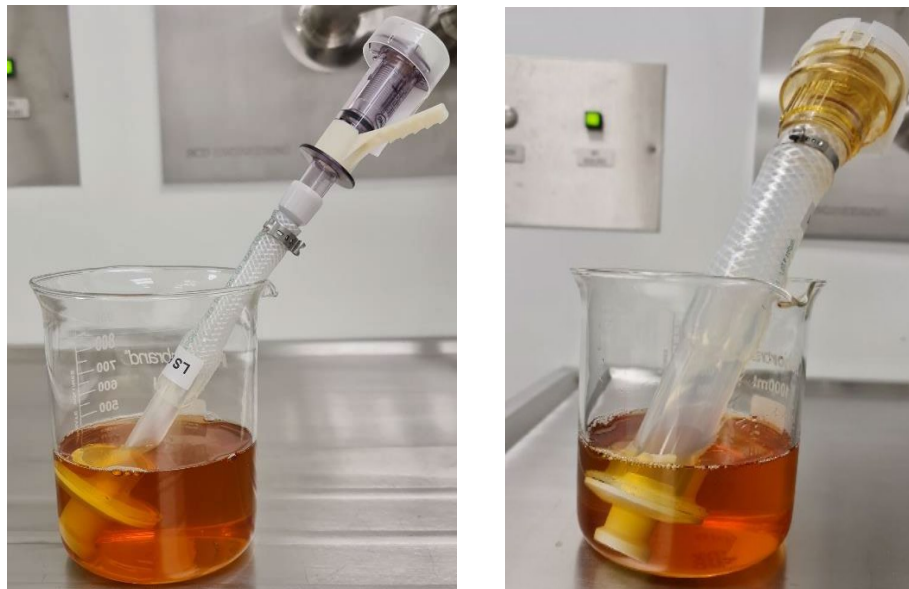
Figure 5. 3/8" ID (left) and 1: ID (right) submerged in *B. diminuta* suspension

The flange-side of a liner was exposed to a *B. diminuta* suspension for five minutes ([Figure 11](#)). A bag containing tryptic soy broth (TSB) was connected to the other, non-exposed, side of the liner with a Pall Kleenpak™ sterile connector. The TSB was transferred from the bag into the liner, and held for five minutes to capture potential contaminants. At the conclusion of the exposure time, the contents of the liner were shifted back into the bag, which was disconnected aseptically using a Sartorius biosealer. The bag was incubated for seven days at 35°C to test for sterility. Results ([Table 1](#), [Table 2](#)) show that the plug prevented contaminants from entering the sterile liner.

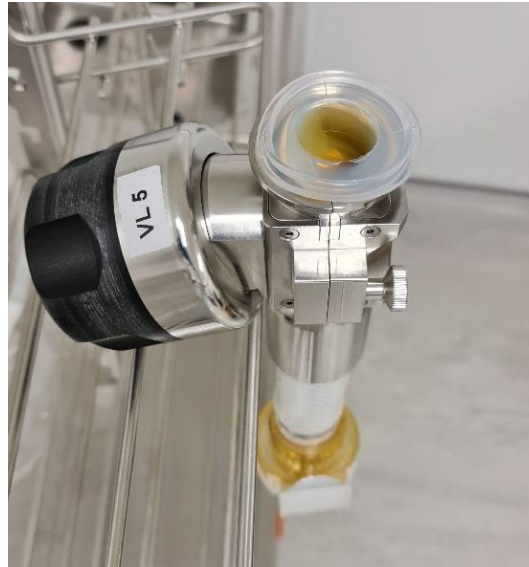
Figure 6. Valve in upside-down position. The cavity was filled with bacterial suspension for 5 minutes.

Each liner, with the plug attached to the flange side, was installed in the valve and the valve was closed. Once the valve was fully closed and the pin was flush with the handle, the plug was removed and the flange was exposed to *B. diminuta* suspension for a total time of 10 minutes (5 minutes upside-down ([Figure 6](#)) and 5 minutes submersed ([Figure 7](#)) to represent the worst-case scenario. After 10 minutes, a bag with tryptic soy broth (TSB) was connected, and a flush was performed. Results ([Table 1](#), [Table 2](#)) show that the closed valve prevented contaminants from entering the sterile liner.

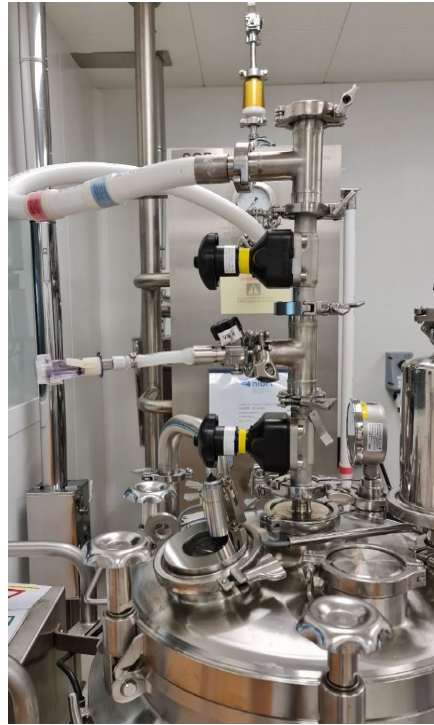
Figure 8. 3/8" ID valve connected to steaming vessel

Each liner was exposed to process air at 2 bar for 45 minutes total (3 x 15 minutes) and then to *B. diminuta* suspension. After exposure, the valve was connected to the vessel and steamed-in-place ([Figure 8](#), [Figure 9](#)) for 20 min at $121^{\circ}\text{C} \pm 2^{\circ}\text{C}$. After sterilization, the two valves adjacent to the testing valve ([Figure 10](#)) were closed to provide a sterile boundary. A bag with TSB was connected and the valve was opened to expose the steamed part of the liner. A TSB flush was carried out for 10 minutes, after which the contents were transferred back to the bag, sealed, and incubated. Results show that no growth occurred following incubation ([Table 1](#), [Table 2](#)).

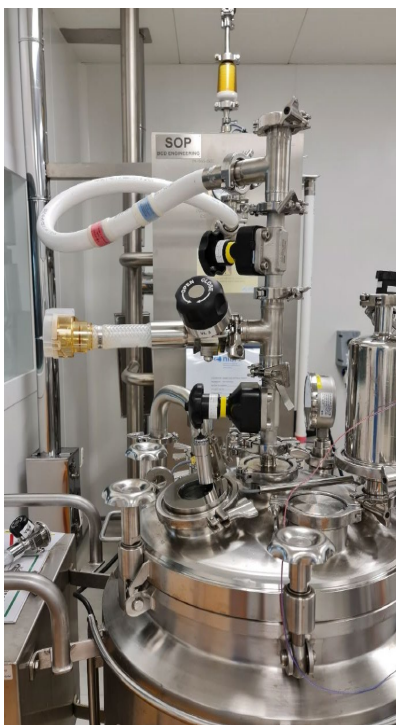
Figure 9. 1" ID valve connected to steaming station

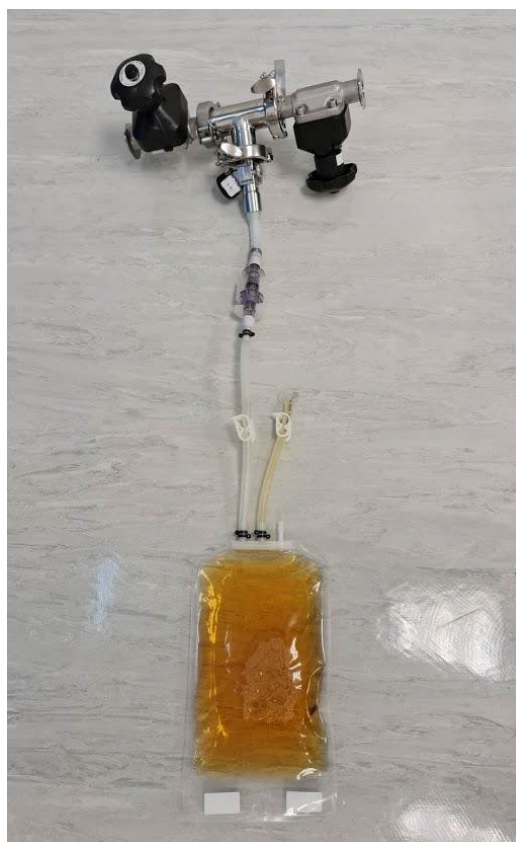
Figure 10. Tested valve shown with adjacent hand valves and TSB in a single-use bag assembly with a Kleenpak connector
